Bulletin 25
Pt.1.

### MINING CONDITIONS

CITY OF SCRANTON, PA.

WILLIAM GRIFFITH AND ELI T. CONNER

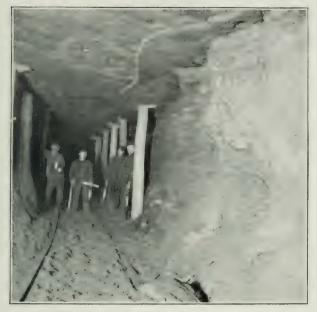
A. GANGWAY CUT THROUGH CULM FLUSHING, OXFORD MINE.

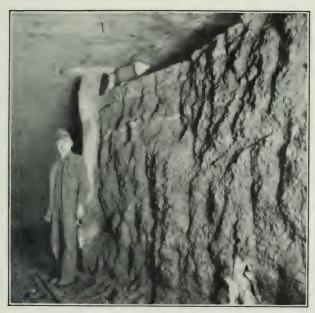
${\it B.}$  Gangway cut through flushing, culm standing as a vertical self-sustaining wall, oxford mine.

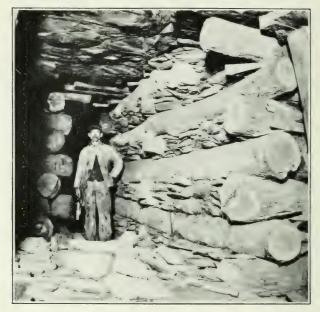
A. TIMBER AND ROCK COG, IN BELLEVUE MINE.

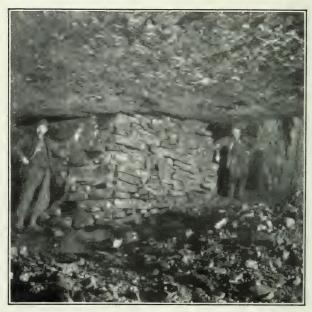
B. GOB PIER IN DUNMORE NO. 2 BED, NATIONAL MINE.

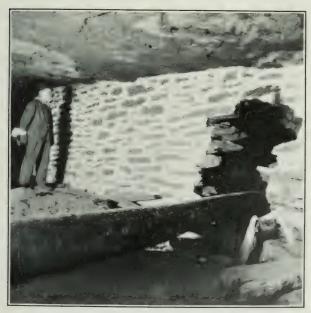
$\it B$ . SIMILAR PIER WITH FLUSH PIPE PASSING THROUGH SHOWS SUPERFICIAL CHARACTER OF MORTAR POINTING.

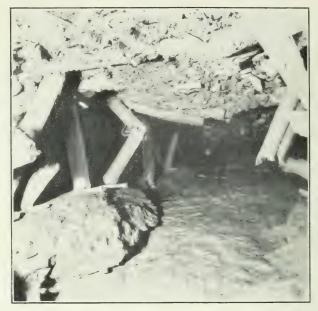
•	squeeze has more or less affected overlying beds and has extended to Leggetts Creek mine, now working under good conditions on east side under Marvine farm.

A. VIEW IN SQUEEZED AREA IN DUNMORE BED, LEGETTS CREEK MINE.

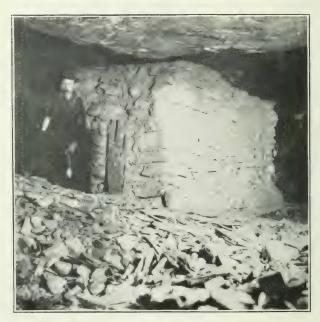
B. SANDSTONE AND CEMENT MASONRY PIER IN DUNMORE NO. 2 BED UNDER SCHOOL NO. 15, NATIONAL MINE.
